Technical paper:

Metrological aspects of assessments of the quality of tubes used as fuel cladding and condenser tubes

By Eugenie D. Kuznetsov, PhD, State Tube Institute, Dnepropetrovsk, Ukraine

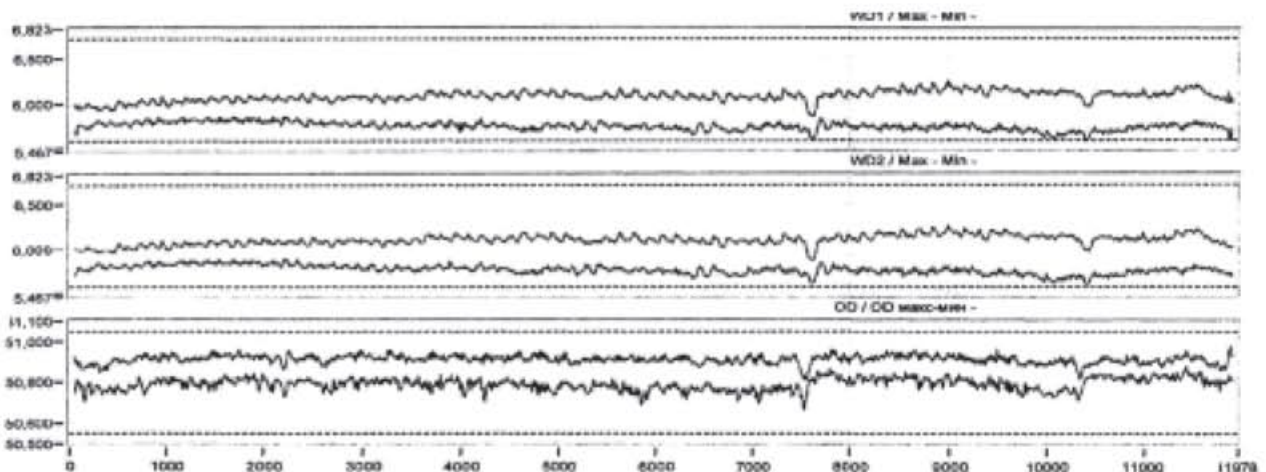
Fig. 3. WD1 and WD2 extreme values of wall thickness, OD extreme values of the diameter on the length of the tube $50,0 \times 6,0 \times 12000$ mm.

The character of such diagrams is shown in Fig. 3. From them we can conclude

that the assessments undertaken in this way do not allow us to achieve a reliable assessment of the interchangeability of the tubes. In other words, all the tubes whose dimensions are within the specified tolerances, will be formally classified as the same, though in fact they differ significantly from each other. As such, conducting a multi-factor experiment to improve the durability of the tubes is not worthwhile.
