Significant improvement in mechanical sealing reliability

Problems with excessive leakage from mechanical seals fitted to high-speed boiler feed pumps were leading to increased maintenance costs and workloads at the Doel 3 and 4 units in Belgium. In search of both an explanation and a solution, the plant's engineers approached Flowserve in the hope that they would provide the answers they needed.

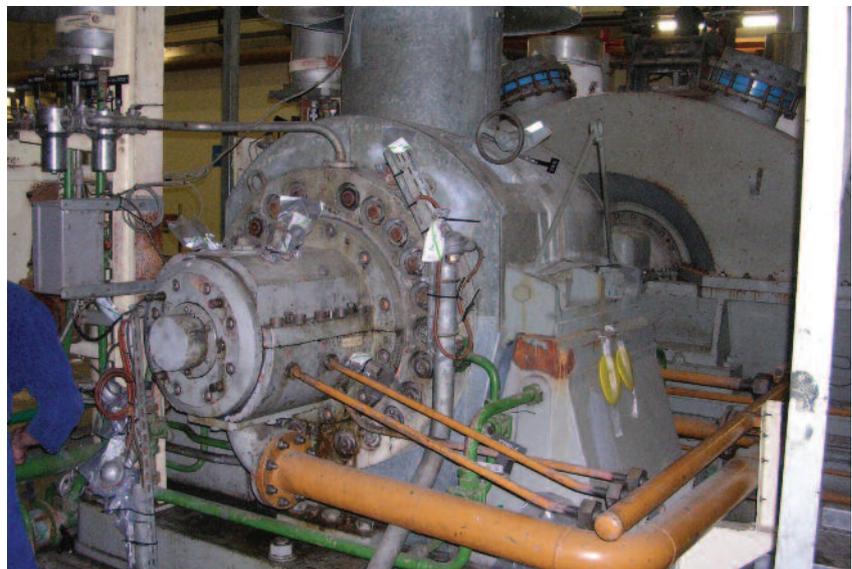
Steam generator feed pump Doel 3.

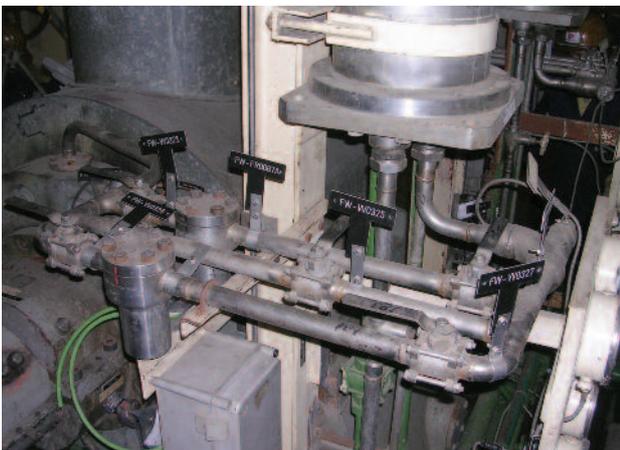
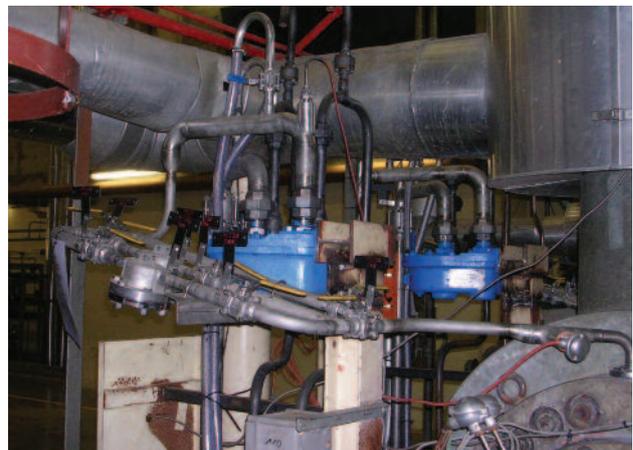
The original seal cooling system (left) and the new optimized seal cooling system

The Flowserve aftermarket philosophy is system-driven, rather than mere component-driven, so detailed recommendations were made to modify the seal's cooling system known as Plan 23. While the original seals operated with relatively high seal loop temperatures, a recommendation was made to install new, extremely efficient seal coolers and exchange all interconnecting seal piping with an increased diameter to

reduce flow resistances. To ensure the new seal piping was correctly executed, seal engineers assisted with the final piping process and instrumentation design (P&ID) and isometrics made by the piping contractor.

On June 14, 2005, when the reactor came online again, sufficient steam was available for the turbine driven pump to be placed into service. Electrabel engineers noticed immediately that the seal loop temperatures were much lower, indicating efficient cooling of the mechanical seals. In addition to an overall reduction of seal loop temperatures of 10-15 °C, the differential between seal inlet and outlet temperature was reduced from 10 °C to about 3-5 °C. Since Electrabel Doel had installed a temporary temperature recorder on the seal piping, accurate measurements and recordings could be made, which later became part of a permanent seal monitoring system. Today, the first two DHTW-8750 seals are still installed and operating, and are as stable as the day they were installed. Although the six year operational goal requested by Electrabel Doel has not yet been fully achieved, the mechanical seals did achieve the agreed 25,000 hours of continuous service. Electrabel Doel intends to keep the Flowserve seals installed for the full six years, after which they will be refurbished.
