# On-site valve overhaul helps major outage at nuclear power station

**Almost 750 valves were successfully overhauled recently, on-site, at the UK's largest Magnox nuclear power station in Wylfa, North Wales. The work was carried out by specialist engineering and technical services company Furmanite, which helped to keep the major shutdown on-schedule.**

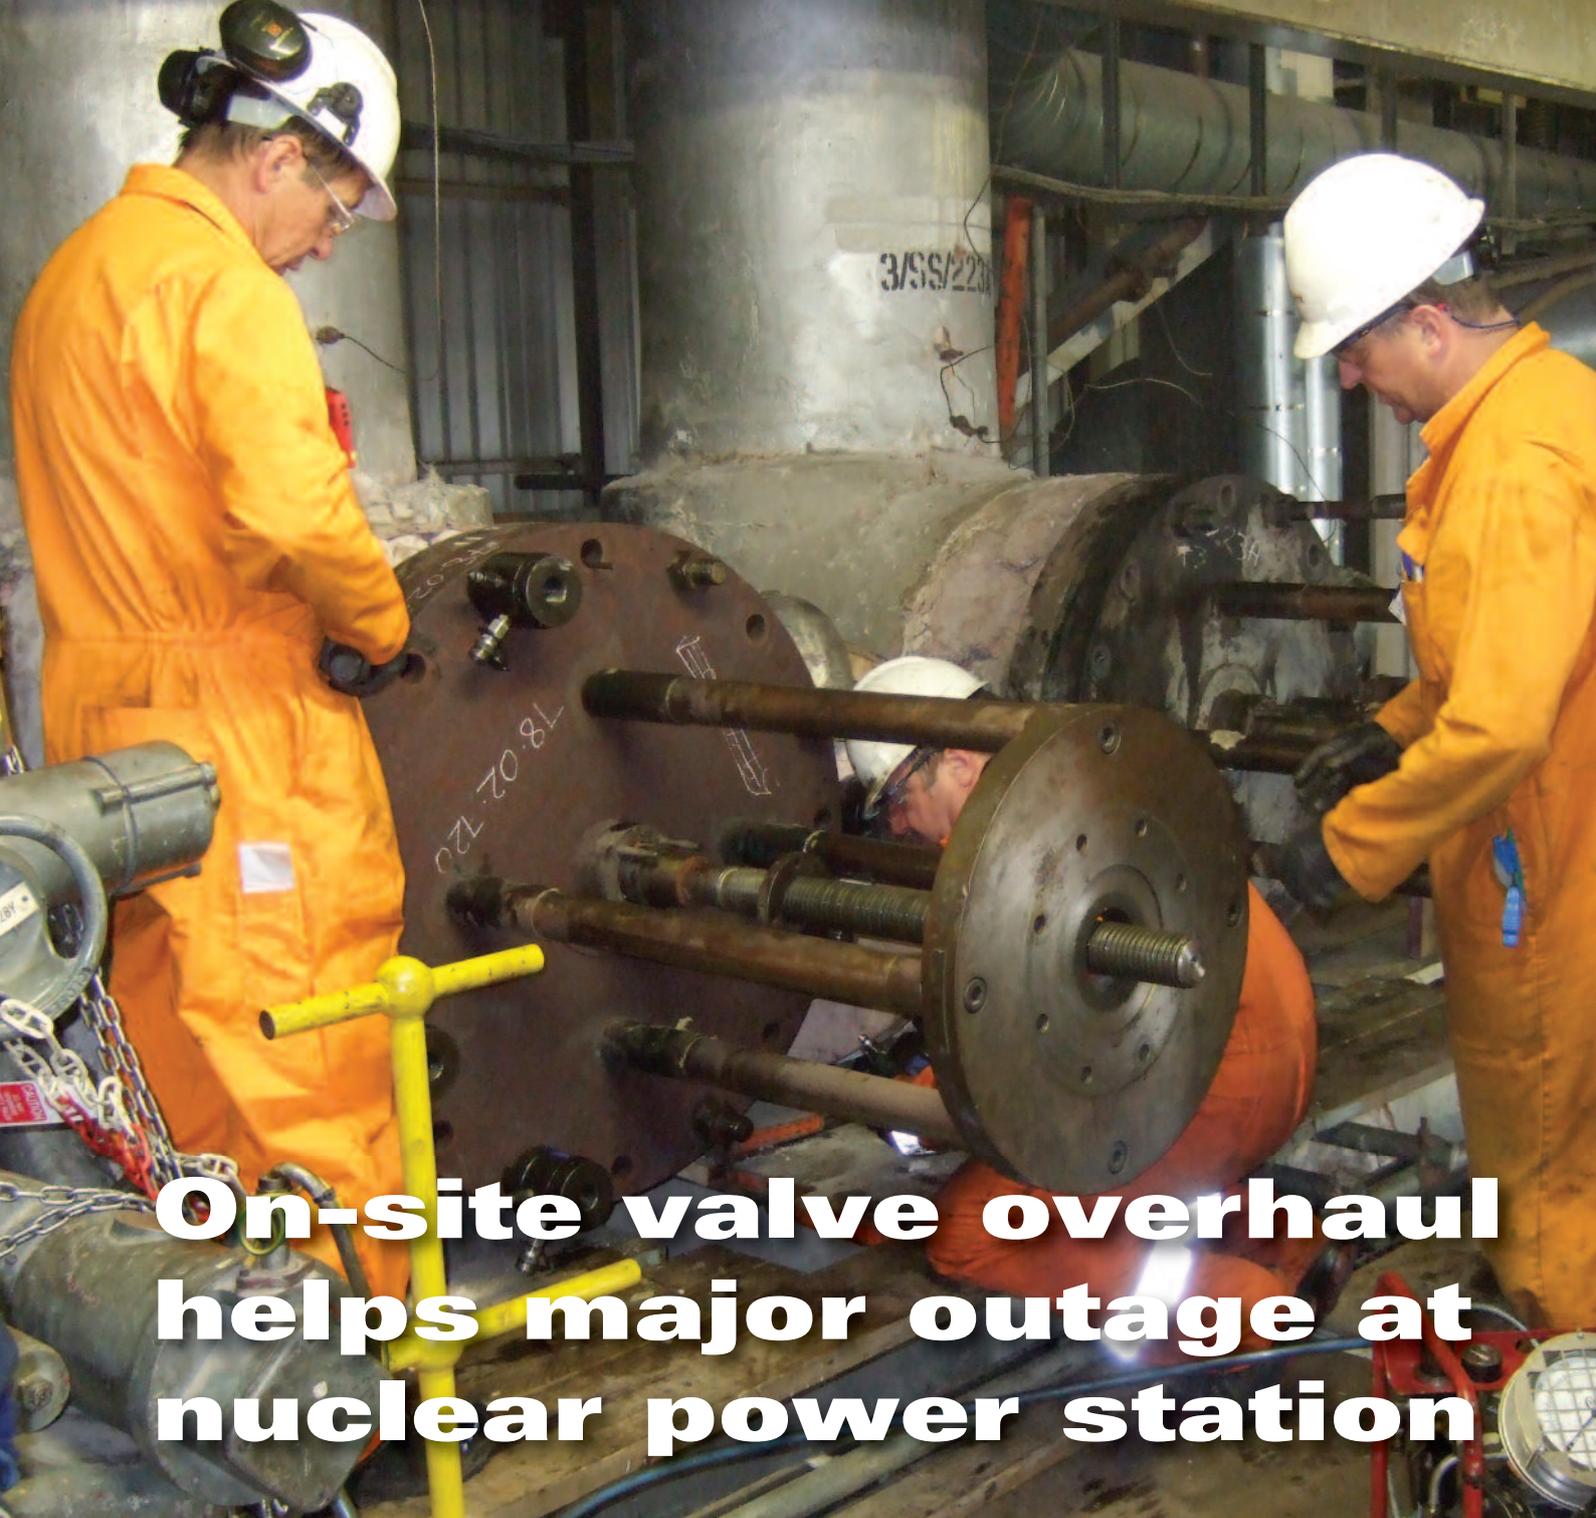
*The overhaul programme included a wide range of valves*
